**Flood Control Project Maintenance
Levee Inspections**

2019 Channel Summary Report

San Joaquin County Flood Control and Water Conservation District

Levee Inspection Report By Mile - Channel 2019

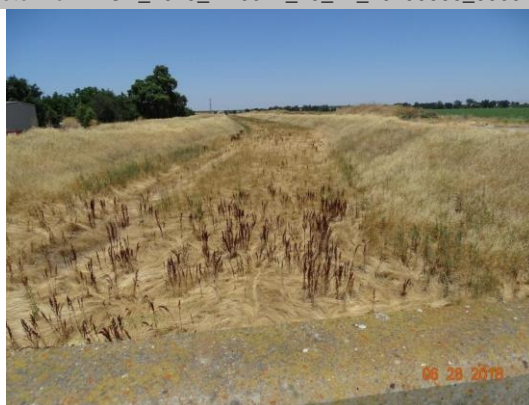
Photo 2 of 2 : CH_2019_NA0017_43_11_20190606_00001.jpg

View of the vegetation in the channel looking upstream, 2018.

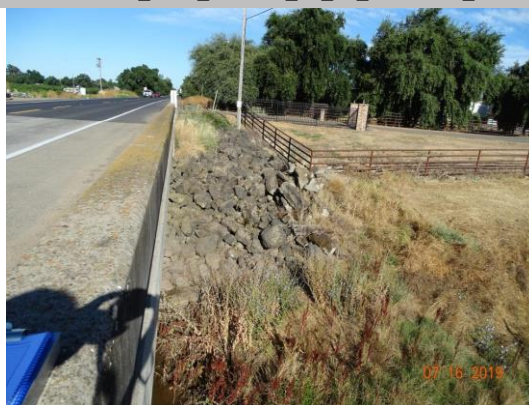
Photo 1 of 2 : CH_2019_NA0017_43_14_20190717_00013.jpg

View of upstream revetments on the right bank of channel. Summer 2019

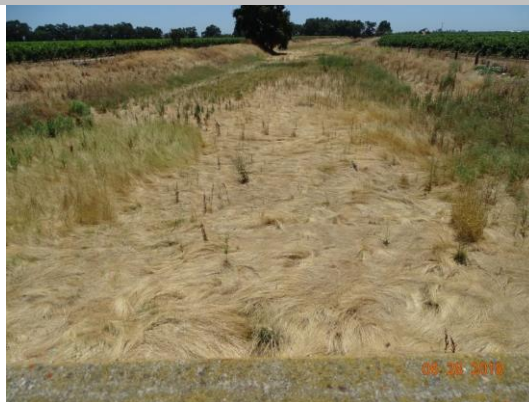
Photo 2 of 2 : CH_2019_NA0017_43_16_20190606_00004.jpg

View of the vegetation looking downstream of the channel. Summer 2018

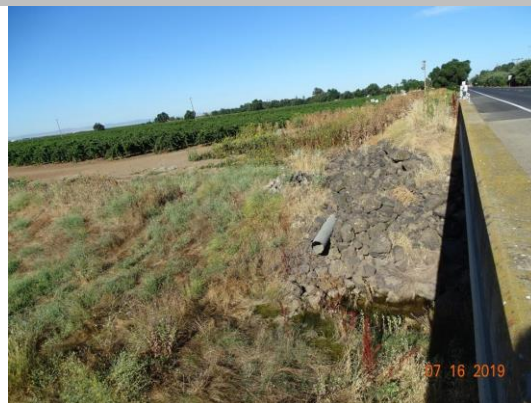
Photo 1 of 2 : CH_2019_NA0017_43_19_20190717_00018.jpg

View of revetments on the right bank of channel looking downstream.
Summer 2019

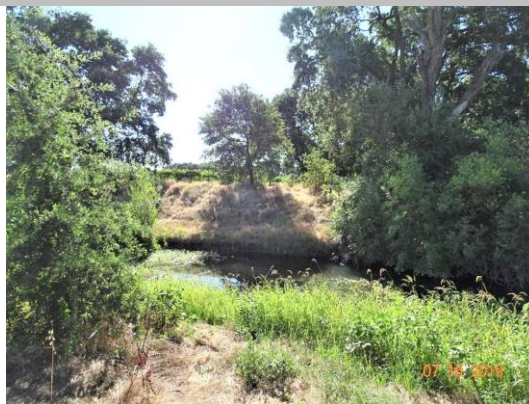
Photo 1 of 3 : CH_2019_NA0017_43_23_20190717_00030.jpg

View of minor erosion on left bank at the confluence. Summer 2019

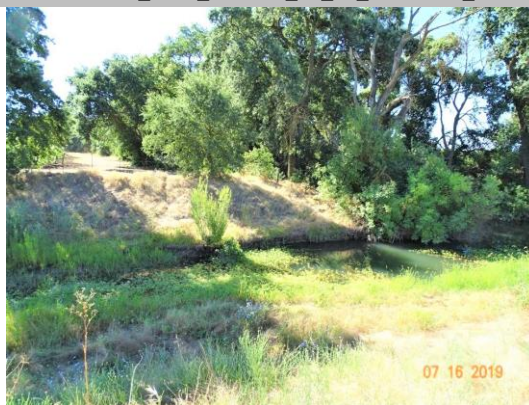
Photo 2 of 3 : CH_2019_NA0017_43_23_20190717_00032.jpg

View of minor erosion on the left bank at the confluence. Summer 2019

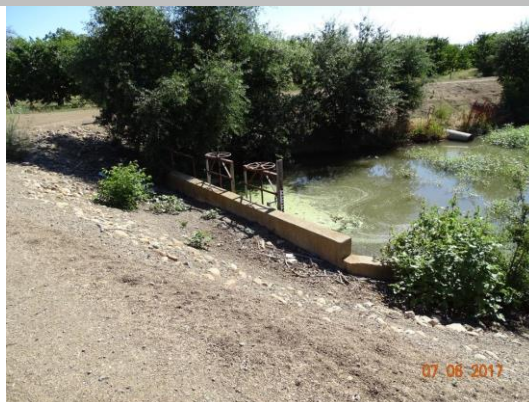
Photo 1 of 1 : CH_2019_NA0017_42_112_20190611_00049.jpg

Inspector Comments: The concrete surface appeared to be in good condition with no negligible spalling, scalling or cracking.

View of the culvert on the upstream of the channel. Summer 2017

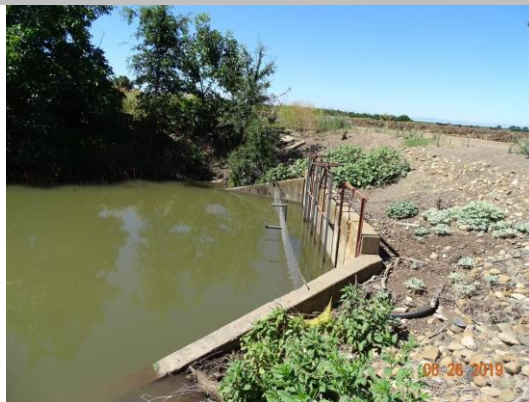
Photo 1 of 1 : CH_2019_NA0017_42_113_20190723_00080.jpg

Inspector Comments: High water prevented inspection of slide gates. During the 2018 inspection slide gates appeared to be in good operational condition.

View of slide gates upstream of the channel. Summer 2019

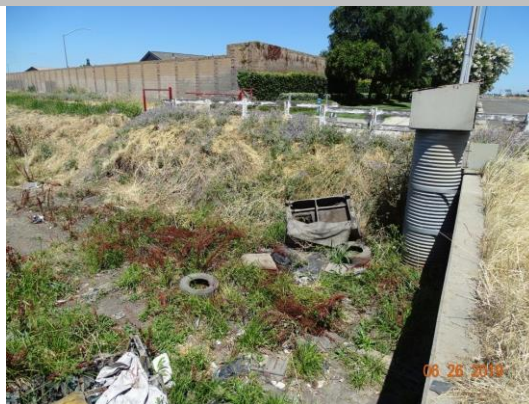
Photo 1 of 1 : CH_2019_NA0017_42_60_20190719_00067.jpg

View of trash and debris looking downstream. Summer 2019

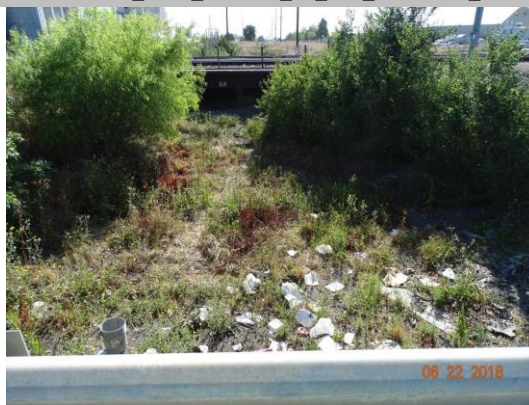
Photo 2 of 2 : CH_2019_NA0017_42_101_20190611_00041.jpg

View of the heavy vegetation on the channel looking upstream during 2018 inspection.

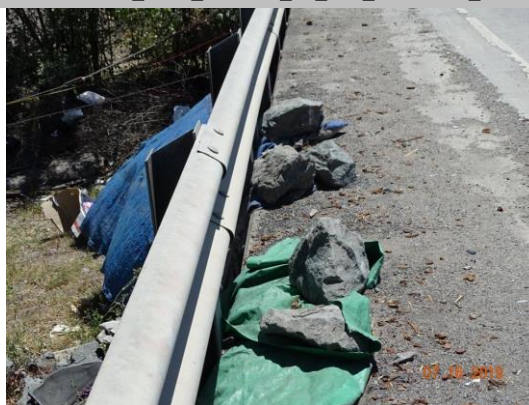
Photo 1 of 1 : CH_2019_NA0017_42_104_20190723_00083.jpg

View looking upstream of revetments displaced by homeless encampment activities. Summer 2019

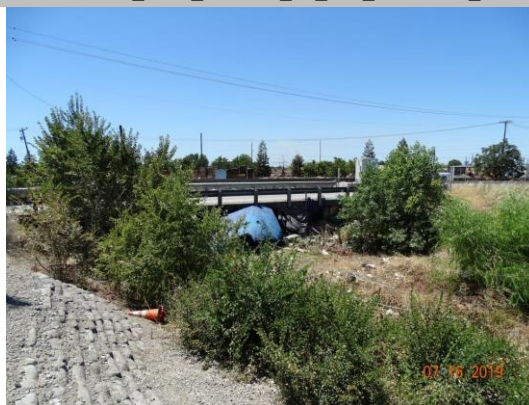
Photo 1 of 2 : CH_2019_NA0017_42_105_20190723_00081.jpg

View of trash and debris upstream end of channel. Summer 2019

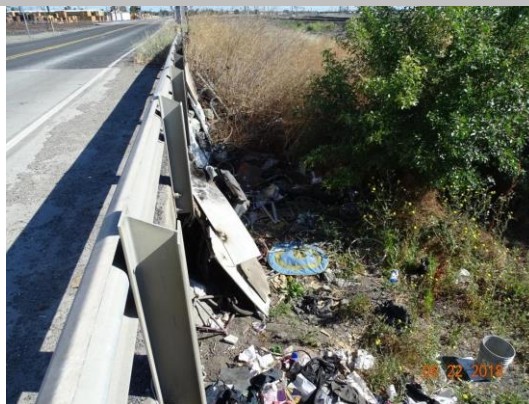
Photo 2 of 2 : CH_2019_NA0017_42_105_20190611_00045.jpg

View of debris on the upstream end of the channel. Summer 2018

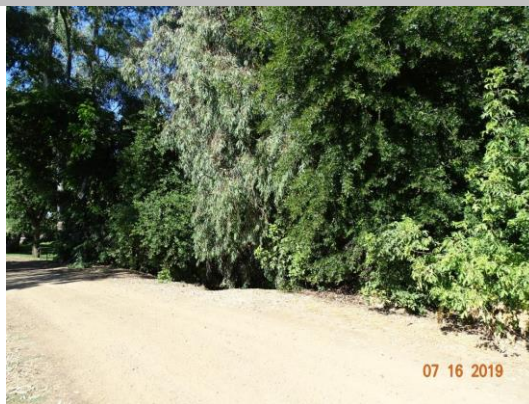
Photo 2 of 3 : CH_2019_NA0017_44_104_20190718_00055.jpg

View of dense vegetation looking downstream. Summer 2019

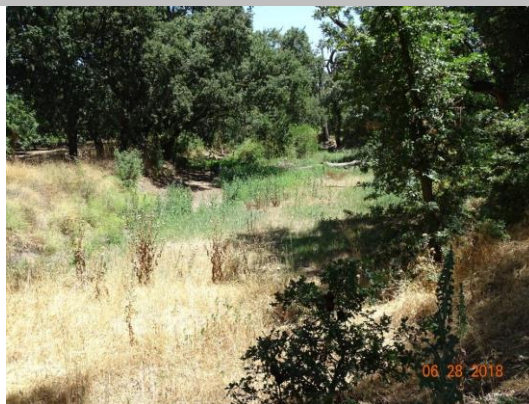
Photo 2 of 2 : CH_2019_NA0017_44_141_20190611_00043.jpg

Tree trunks and vegetation may impede the flow within the channel.
Summer 2018

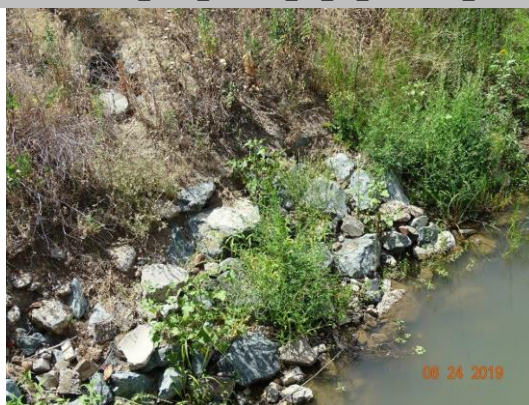
Photo 1 of 3 : CH_2019_NA0017_44_59_20190718_00074.jpg

Inspector Comments: Existing riprap is visible, however there are area of sloughing with displaced or missing riprap near the top of the left bank.

View of existing revetments on left bank of channel. Summer 2019

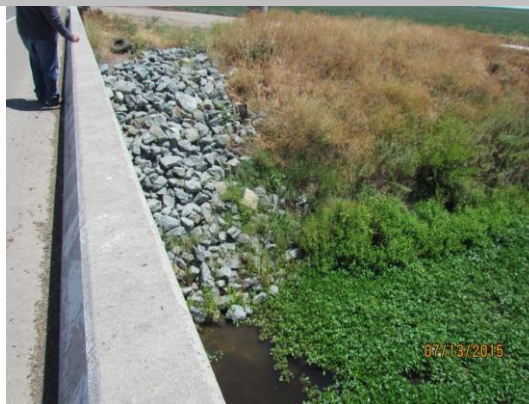
Photo 3 of 3 : CH_2019_NA0017_44_59_20190611_00020.jpg

Inspector Comments: Existing riprap is visible, however there are area of sloughing with displaced or missing riprap near the top of the left bank.

View of existing revetments on the channel banks looking downstream.

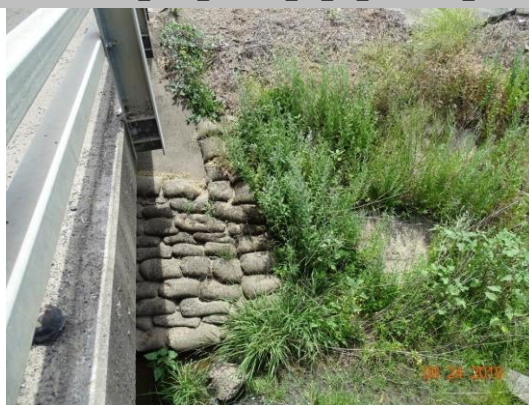
Photo 1 of 2 : CH_2019_NA0017_44_69_20190718_00078.jpg

Inspector Comments: There is minor erosion on the left bank that should be monitored or repaired.

View of existing revetments looking downstream. Summer 2019

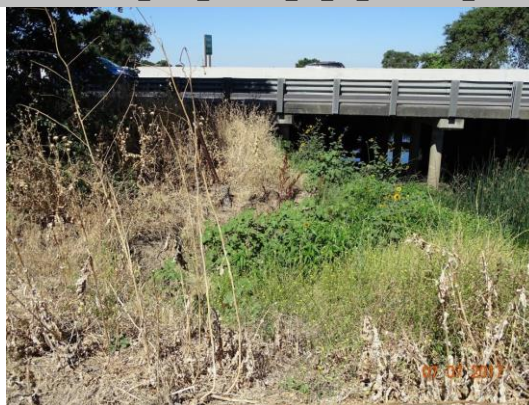
Photo 2 of 2 : CH_2019_NA0017_44_83_20190611_00030.jpg

View of the erosion on the channel bank looking upstream. Summer 2017

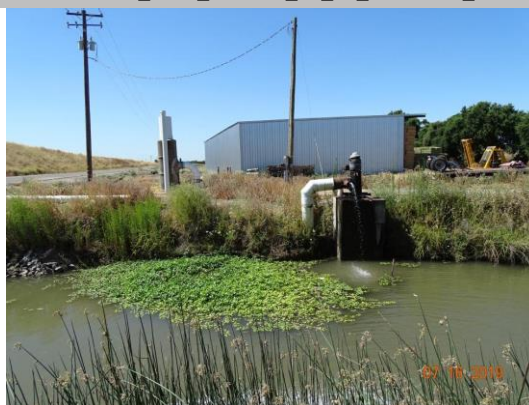
Photo 1 of 2 : CH_2019_NA0017_45_18_20190718_00041.jpg

View looking downstream of minor left bank erosion. Summer 2019

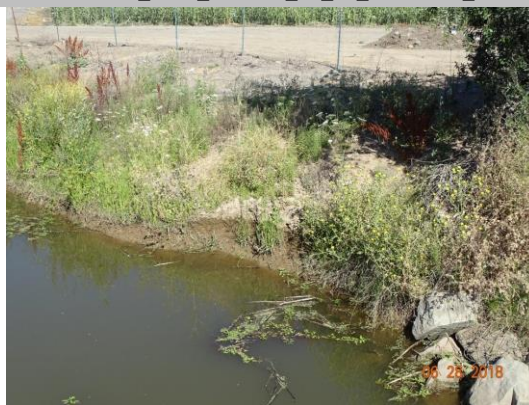
Photo 2 of 2 : CH_2019_NA0017_45_28_20190612_00012.jpg

View of the erosion on the right bank of the channel. Summer 2018
